OHIO RIVER BASIN
CRABTREE CREEK
WESTMORELAND COUNTY

GREENWALT DAM

PHASE I INSPECTION REPORT
NATIONAL DAM INSPECTION PROGRAM

Best Available Copy JULY 1980

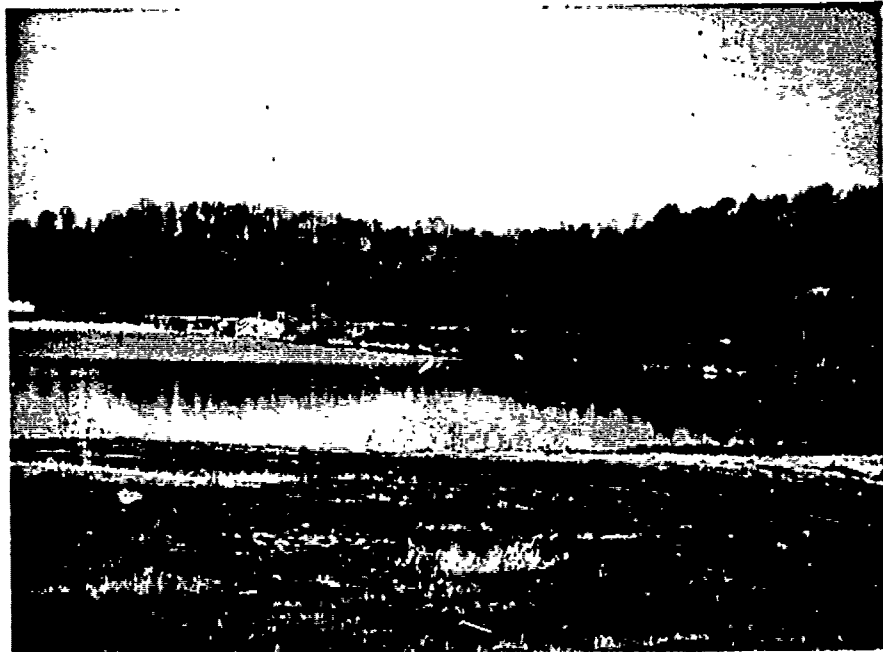
PHOTO 1. UPSTREAM SLOPE

An erosional gully was noted on the upstream slope just left of the principal spillway left training wall. The erosion appeared to be the result of surface runoff from the embankment crest.

- (1) Observed erosion of the upstream slope and deterioration of the upstream slope riprap protection.
- (2) Observed unevenness and wheel rutting of the embankment crest.
- (3) Observed sloughing of the downstream slope.
- (4) Observed high groundwater level in the embankment.
- (5) Observed erosion of foot paths on the downstream slope.
- (6) Observed lack of maintenance of the upstream slope, downstream slope and crest of the embankment as evidenced by excessive vegetal cover and the above noted conditions.

(5) Replace lost riprap along the upstream slope of the embankment.

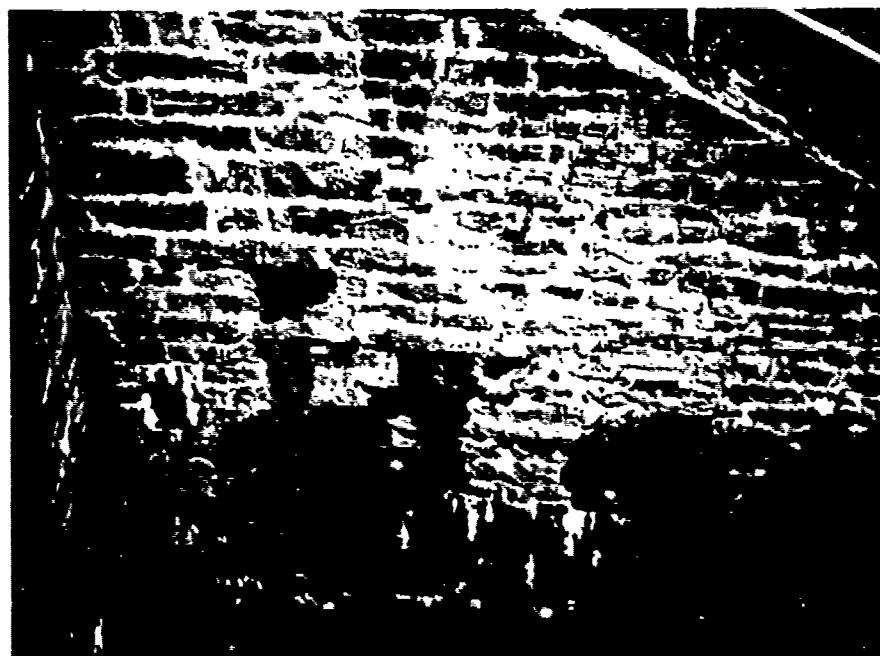
PHOTO 4. LEFT SPILLWAY WALL

The left training wall did not contain any major cracking although numerous wet spots and small seeps were observed.

Leaks and seepage through the left training wall are also considered to be a deficiency.
